Inspection Report Minerals Regulatory Program

Withe Name: Black Knight	Permit number: 5/015/078			
Operator or Permittee Name:	Inspection Date: June 30, 2004			
GoldTerra				
Permittee Mailing Address:				
4088 E. Airport Rd., Box 783, Price, UT 84501				
Inspector(s): Paul Baker				
Participants: None present	Inspection Start Time: Abt. 2:25 PM			
	Inspecti	on End Tin	ne: Abt. 2:40 I	PM
Weather: Mostly clear, 90's	Site location/Area Inspected (i.e. Pit #):			
	Entire si	te		
Permit Status: Inactive	Surface	Ownership	: SITLA	
Current Acreages:	Mineral	l Ownership	p: SITLA	
Total Permitted (Bonded): 5	Mineral Mined: Gold from clay			
Total Disturbed: About 1	Type of	Mine: Surf	ace	
Elements of Inspection	Evaluated	N/A	Comment	Enforcement

ATTACHMENT Photographs S/015/078, Black Knight, GoldTerra Inspection Dated: June 30, 2004; Report Dated: September 3, 2004

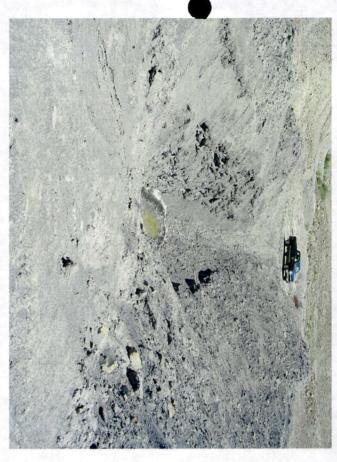
General comment: I last visited this site when the Division had a proposal for a large mine. I do not believe the pit (Photo 1) was present at the time, but I could be mistaken. When the site is reclaimed, a portion of the road should be included although part of the road is probably used by people with grazing permits.

The pit has been graded so it would be possible for a person or an animal falling in to get out.

Photo 1. The pit with some of the excavated material around it. This is essentially all the disturbance at the site.
